**2011Addendum: An Assessment of
Environmental Problems Associated with Recycling of
Hazardous Secondary Materials**

June 30, 2011

U.S. Environmental Protection Agency
Office of Resource Conservation and Recovery

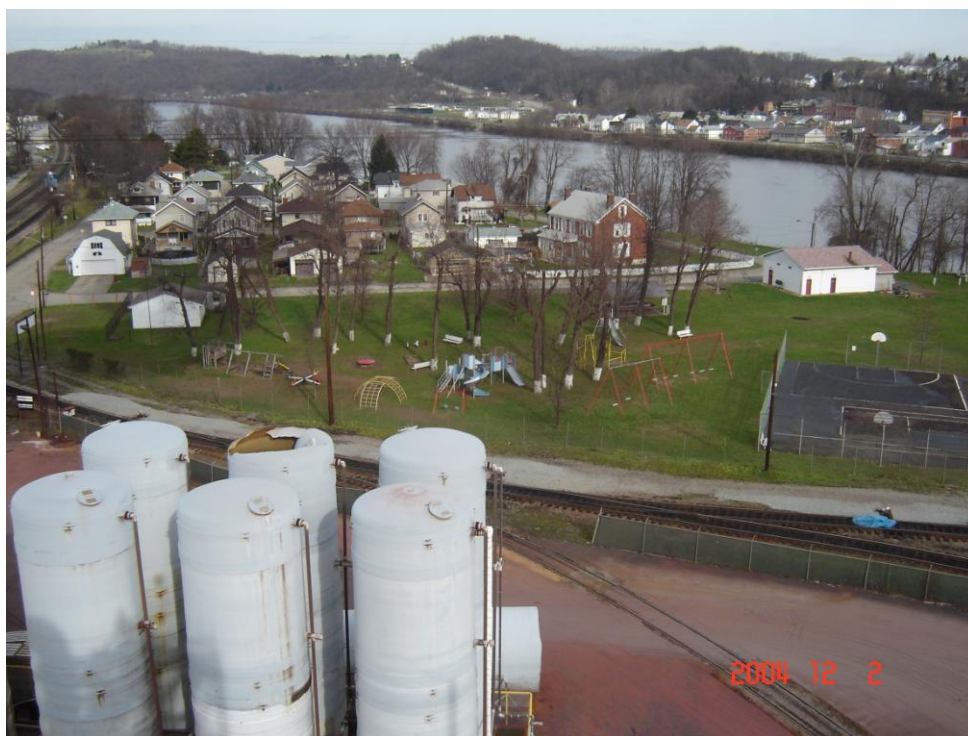
Figure 1. Ruptured Tank at the AMROX Facility and Nearby Community Playground

On or about April 18, 2011, an aboveground storage tank at the facility split open, releasing approximately 27,300 gallons of regenerated hydrochloric acid solution, with a pH of less than 1.0. At the time of the release, the emergency containment area at the facility contained accumulated water and was not able to contain the released volume of hydrochloric acid, and hydrochloric acid overflowed from the emergency containment area.

PADEP reviewed the company's inspection records and learned of multiple and persistent leaks from five of the ten tanks in operation from May 23 to August 6, 2009. These issues were in addition to defects that have required repair over the previous four years, including interior and exterior cracks and patch failures.

PADEP issued an Administrative Order on April 27, 2011, requiring AMROX to evaluate several acid tanks at the facility. Among other things, the April 27, 2011 Administrative Order required AMROX to

reduce the volume by half within eight remaining tanks, and demonstrate that it would be safe to allow the tanks to continue in operation. AMROX did reduce the contents of the tanks to 50% of their capacity, but failed to document the integrity and fitness for operation of the tanks. On May 11, 2011, PADEP and a retained expert inspected the failed tank and could not identify an obvious cause for the failure. On May 5 and May 11, 2011, the PADEP observed acid continuing to leak from various tanks, as well as deteriorated concrete supports beneath one or more of these tanks. On May 12, 2011 PADEP ordered AMROX to empty several older acid tanks. AMROX subsequently provided an engineering analysis that with the installation of additional reinforcing bands around each tank that the tanks would remain structurally sound at 50% capacity. PADEP issued a third order on May 18, 2011 requiring an accelerated series of tank inspections and a failure analysis of the damaged tank.
